ATTENTION HOME OWNERS

MAINTAIN YOUR CHROME PLATED FLOOR WASTE GRATES

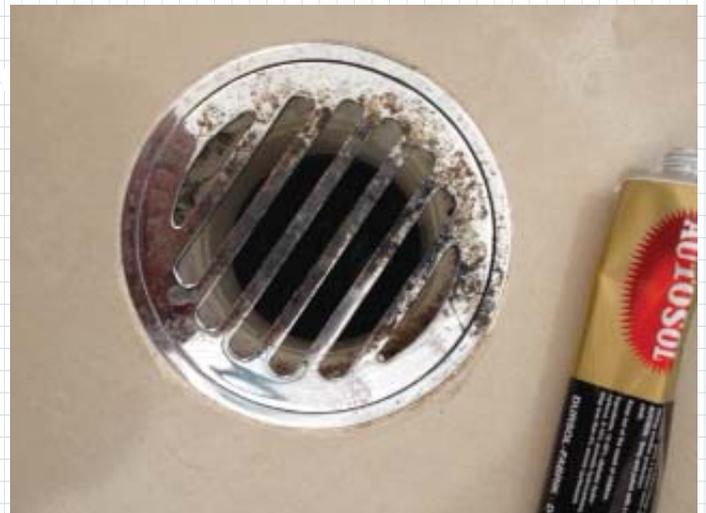
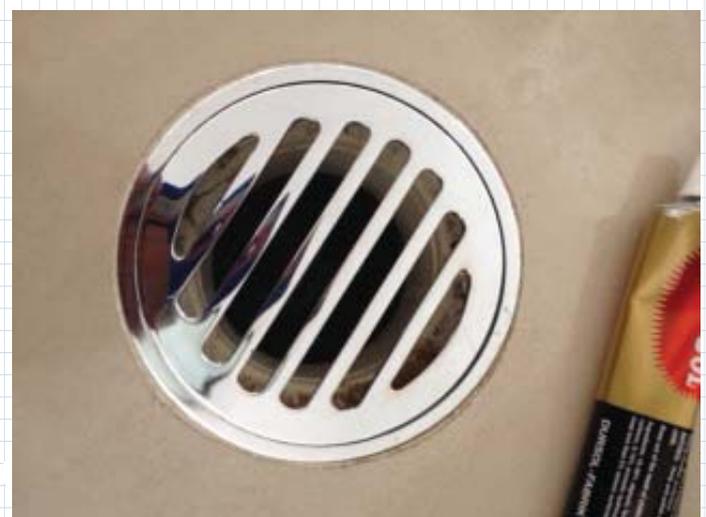
If left unattended these grates may quickly take on a tarnished or rusted appearance. In many cases small black spots will begin to appear and if not cleaned will spread across the surface of the grate. This effect is caused by bacterial spores attaching to the chrome and multiplying across the grate. This unsightly growth can easily be removed by using a non-abrasive metal cleaner and soft cloth. Once cleaned the integrity of the chrome finish will remain.

It is worth noting that this problem is not isolated to Plastec grates and the same care and cleaning should be applied to other wastes and grates in the household. For best results at removing bacterial growth we recommended a product called Autosol Metal Cleaner which can be purchased at any hardware or auto supplier.

Clean by using a non-abrasive metal cleaner and soft cloth
